Contract #: 04-0120F4Cty: SF/ALA Rte: 80 PM: 13.2/13.9File #: 69.28**WELDING INSPECTION REPORT****Resident Engineer:**Siegenthaler, Peter**Address:** 333 Burma Road**City:** Oakland, CA 94607**Report No:** WIR-021588**Date Inspected:** 16-Feb-2011**Project Name:** SAS Superstructure**OSM Arrival Time:** 700**Prime Contractor:** American Bridge/Fluor Enterprises, a JV**OSM Departure Time:** 1900**Contractor:** Zhenhua Port Machinery Company, Ltd (ZPMC), Changxing Island **Location:** Shanghai, China**CWI Name:** Mr. Xu Le Feng.**CWI Present:** Yes No**Inspected CWI report:** Yes No N/A**Rod Oven in Use:** Yes No N/A**Electrode to specification:** Yes No N/A**Weld Procedures Followed:** Yes No N/A**Qualified Welders:** Yes No N/A**Verified Joint Fit-up:** Yes No N/A**Approved Drawings:** Yes No N/A**Approved WPS:** Yes No N/A**Delayed / Cancelled:** Yes No N/A**Bridge No:** 34-0006**Component:** Tower and Orthotropic Box Girder (OBG)**Summary of Items Observed:**

WELDING INSPECTION REPORT

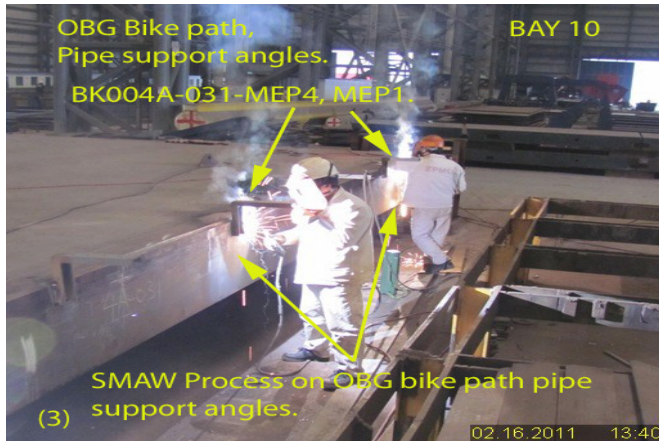
This QA Inspector observed ZPMC qualified welding personnel identified as 052930, 500363, Perform Shielded Metal Arc Welding (SMAW) on OBG Bike path pipe support angles. Joint identified as BK004A-031-MEP1, MEP4. ZPMC CWI Identified as Guo Yan Fei. The welding parameters as measured using QC's calibrated instrument appeared to be in general compliance with WPS-B-P-2112, and WPS-B-P-2113. For more information see attached picture number 3.
